## Side Terminal Batteries? Really?

*Text and Photos By Ron Panzer*

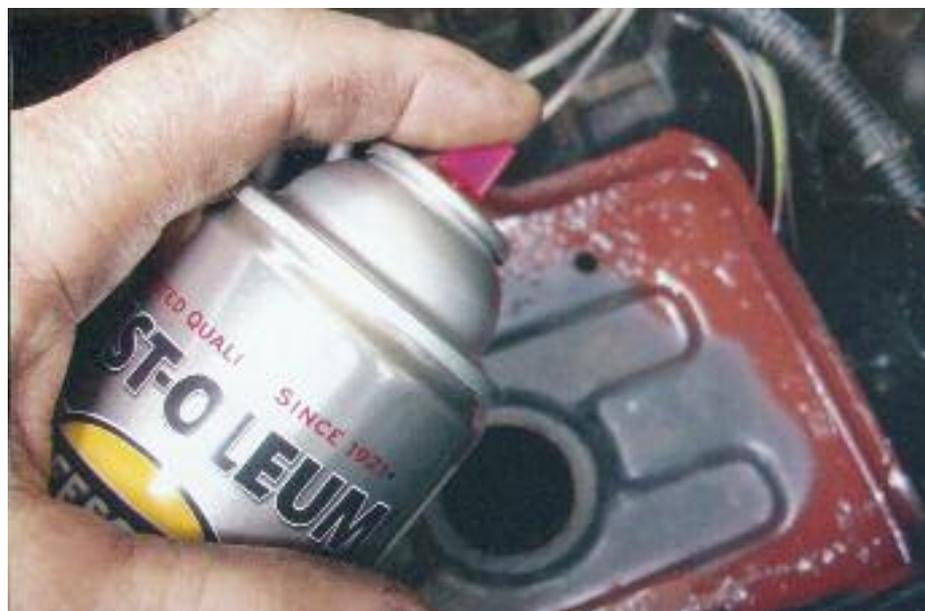
If the corrosion isn't bad enough to remove the tray, clean it up with hot water and air dry. Later, use several coats of Rustoleum primer, then gloss black, to prevent further rusting.

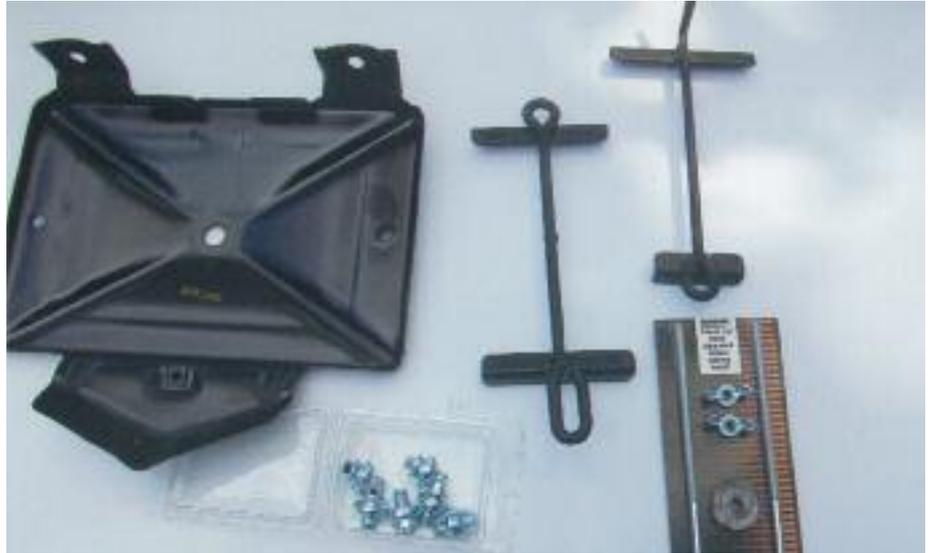
**A number of battery parts are still out there, even from GM, but full-size cars suffer the most. Universal pieces can do the trick with a bit of tweaking until you can get your hands on NOS or reproduction parts.**

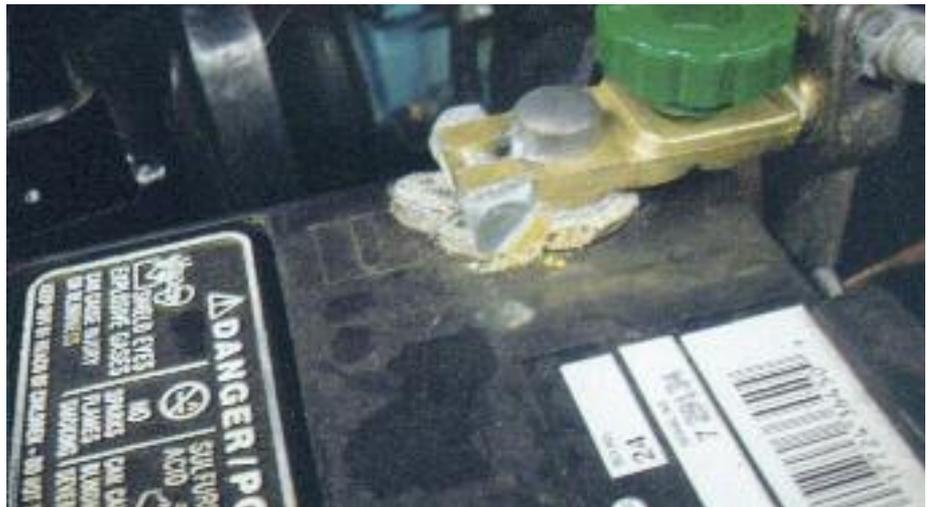
**A perfect example of forcing the cable too far down on the post- anything that touches the battery case will corrode. These disconnects are great for cars that spend most of their lives sitting.**

Keeping the car battery completely clean is the only solution for preventing the formation of corrosion. Also, don't force the cable ends down until they touch the top battery case- leave them up 1/8-inch. Make a thin pad to place under the battery

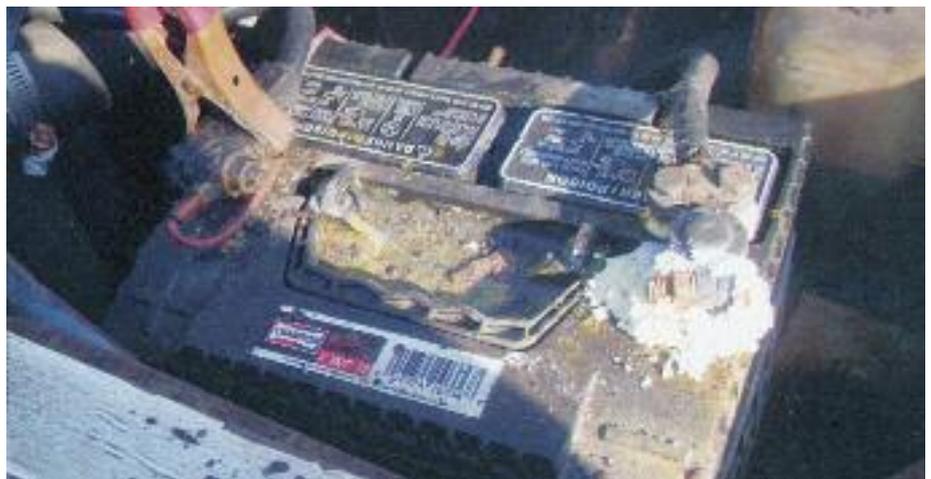
**As a rule of thumb, the corrosion begins on the positive post- but not always, as you see here. It loves dirt and moisture.**

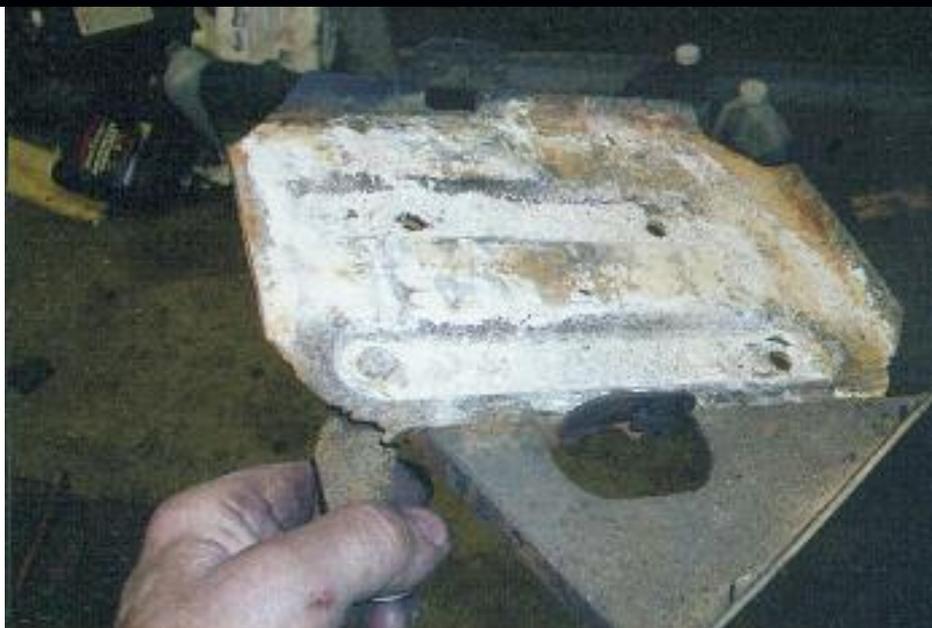
Here's a tray from a '59 Bonneville that looked just fine until I pulled the battery for another repair. Some of these trays are assembled like a bomb shelter.

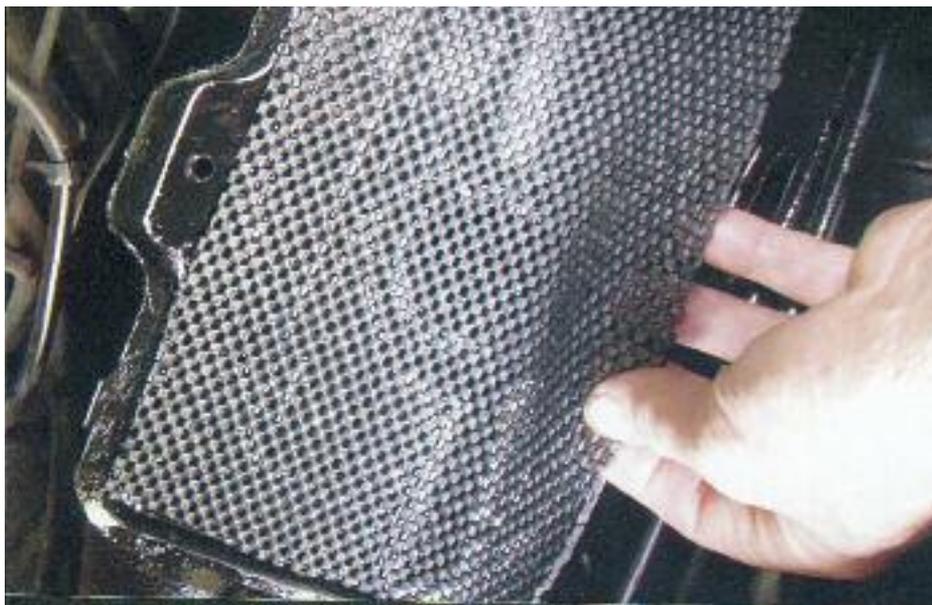
I cut these rubber pads from rolls of tool box drawer liner to set the battery on. With the battery in place, not even Rick Gonser could see it and deduct points!

and keep it from touching the metal tray. Leaving a battery unsecured to jump around on the tray can cut its life by a half. Universal parts are available to secure any battery while you chase factory originals, so that excuse won't fly here. The top post battery is still the better and far easier to spot beginning corrosion. The side post must be taken apart to verify its condition.
